HOME REPORT

173 MALLARD TERRACE
EAST KILBRIDE
GLASGOW
G75 8UF

Energy Performance Certificate (EPC)

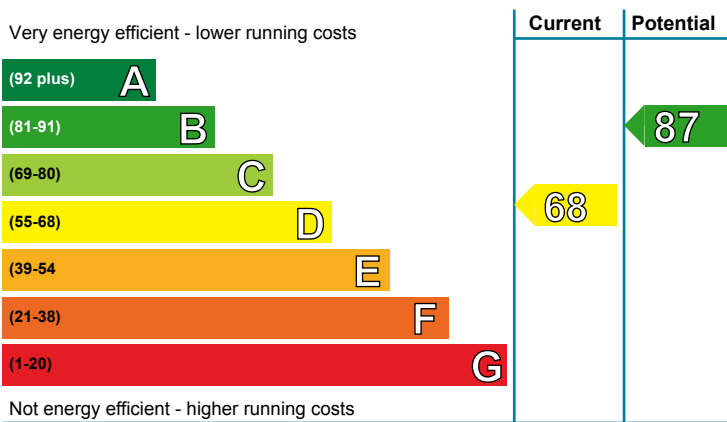
Energy Efficiency Rating

This graph shows the current efficiency of your home, taking into account both energy efficiency and fuel costs. The higher this rating, the lower your fuel bills are likely to be.

Your current rating is **band D (68)**. The average rating for EPCs in Scotland is **band D (61)**.

The potential rating shows the effect of undertaking all of the improvement measures listed within your recommendations report.

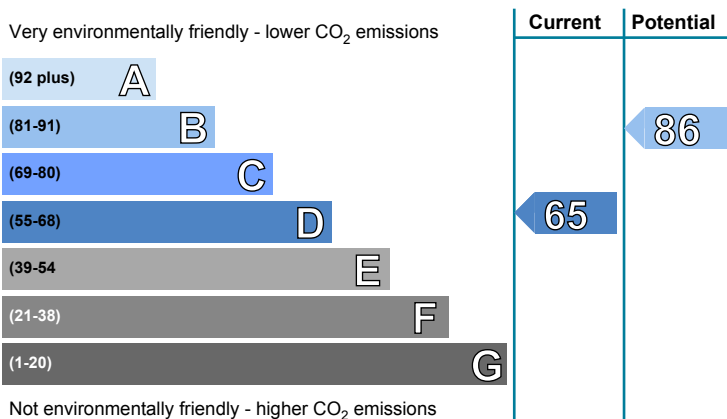
Environmental Impact (CO₂) Rating

This graph shows the effect of your home on the environment in terms of carbon dioxide (CO₂) emissions. The higher the rating, the less impact it has on the environment.

Your current rating is **band D (65)**. The average rating for EPCs in Scotland is **band D (59)**.

The potential rating shows the effect of undertaking all of the improvement measures listed within your recommendations report.
