Home Report

Scottish Single Survey

Property address	18 Shira Terrace East Kilbride Glasgow G74 2HU
Customer	William & Ina McArthur
Customer address	18 Shira Terrace East Kilbride Glasgow G74 2HU
Prepared by	Shepherd Chartered Surveyors
Date of inspection	01/05/2024

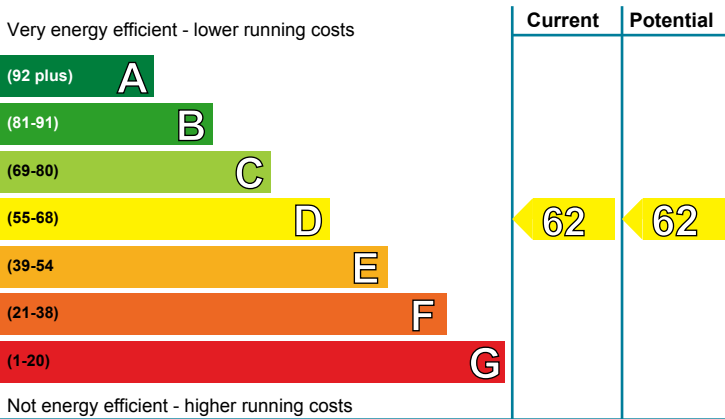
Energy Efficiency Rating

This graph shows the current efficiency of your home, taking into account both energy efficiency and fuel costs. The higher this rating, the lower your fuel bills are likely to be.

Your current rating is **band D (62)**. The average rating for EPCs in Scotland is **band D (61)**.

The potential rating shows the effect of undertaking all of the improvement measures listed within your recommendations report.

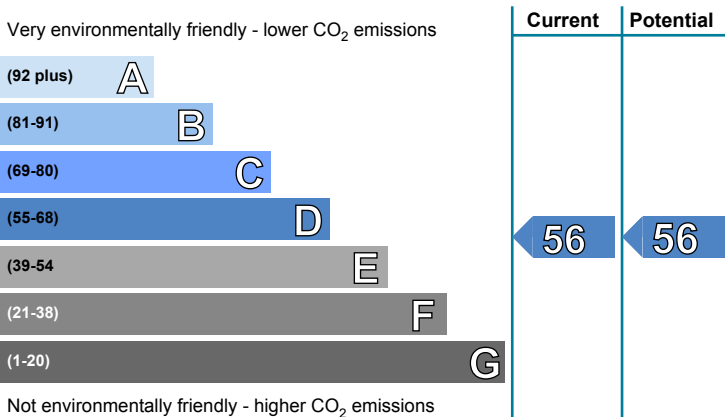
Environmental Impact (CO₂) Rating

This graph shows the effect of your home on the environment in terms of carbon dioxide (CO₂) emissions. The higher the rating, the less impact it has on the environment.
