## HOME REPORT

24 CAMPSIE ROAD  
EAST KILBRIDE  
GLASGOW  
G75 9GE

# ENERGY REPORT

# Energy Performance Certificate (EPC)

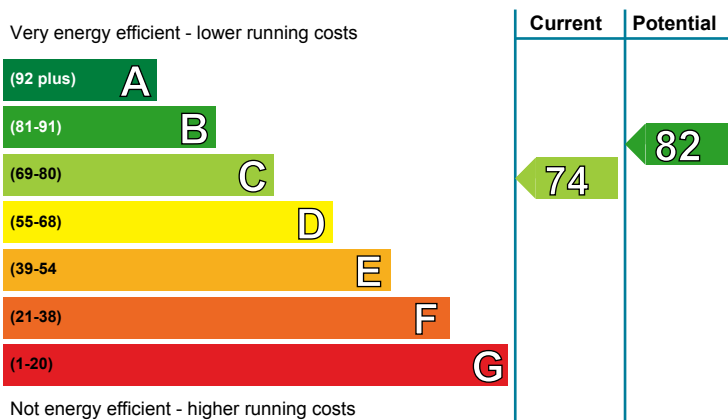
## Energy Efficiency Rating

This graph shows the current efficiency of your home, taking into account both energy efficiency and fuel costs. The higher this rating, the lower your fuel bills are likely to be.

Your current rating is **band C (74)**. The average rating for EPCs in Scotland is **band D (61)**.

The potential rating shows the effect of undertaking all of the improvement measures listed within your recommendations report.
