HOME REPORT

6 KILCHATTAN DRIVE
GLASGOW
G44 4PY

Energy Performance Certificate (EPC)

6 KILCHATTAN DRIVE, GLASGOW, G44 4PY

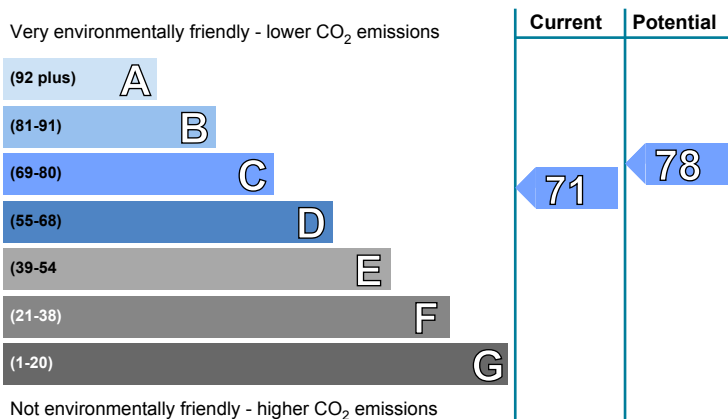
Environmental Impact (CO₂) Rating

This graph shows the effect of your home on the environment in terms of carbon dioxide (CO₂) emissions. The higher the rating, the less impact it has on the environment.

Your current rating is **band C (71)**. The average rating for EPCs in Scotland is **band D (59)**.

The potential rating shows the effect of undertaking all of the improvement measures listed within your recommendations report.
