HOME REPORT

72 COLONSAY
EAST KILBRIDE
GLASGOW
G74 2HF

Energy Performance Certificate (EPC)

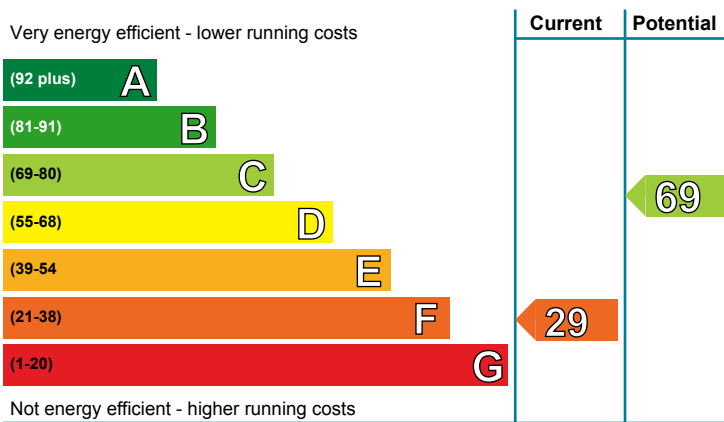
Energy Efficiency Rating

This graph shows the current efficiency of your home, taking into account both energy efficiency and fuel costs. The higher this rating, the lower your fuel bills are likely to be.

Your current rating is **band F (29)**. The average rating for EPCs in Scotland is **band D (61)**.

The potential rating shows the effect of undertaking all of the improvement measures listed within your recommendations report.

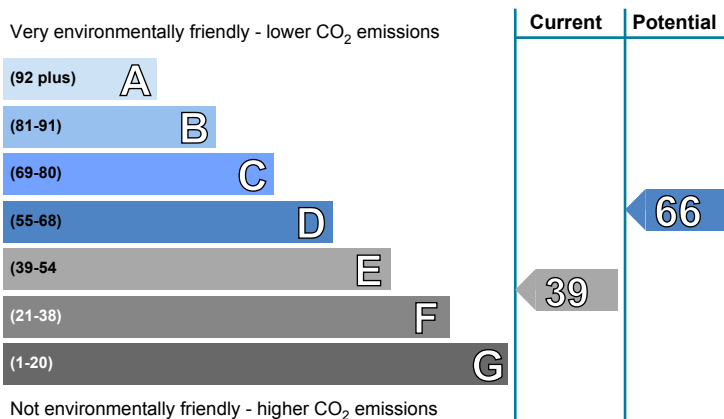
Environmental Impact (CO₂) Rating

This graph shows the effect of your home on the environment in terms of carbon dioxide (CO₂) emissions. The higher the rating, the less impact it has on the environment.

Your current rating is **band E (39)**. The average rating for EPCs in Scotland is **band D (59)**.

The potential rating shows the effect of undertaking all of the improvement measures listed within your recommendations report.
