## HOME REPORT

58 PITCAIRN CRESCENT  
EAST KILBRIDE  
GLASGOW  
G75 8TP

# ENERGY REPORT

# Energy Performance Certificate (EPC)

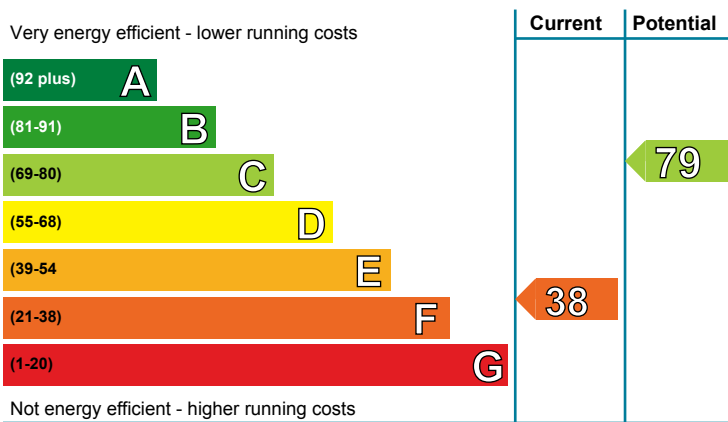
## Energy Efficiency Rating

This graph shows the current efficiency of your home, taking into account both energy efficiency and fuel costs. The higher this rating, the lower your fuel bills are likely to be.

Your current rating is **band F (38)**. The average rating for EPCs in Scotland is **band D (61)**.

The potential rating shows the effect of undertaking all of the improvement measures listed within your recommendations report.

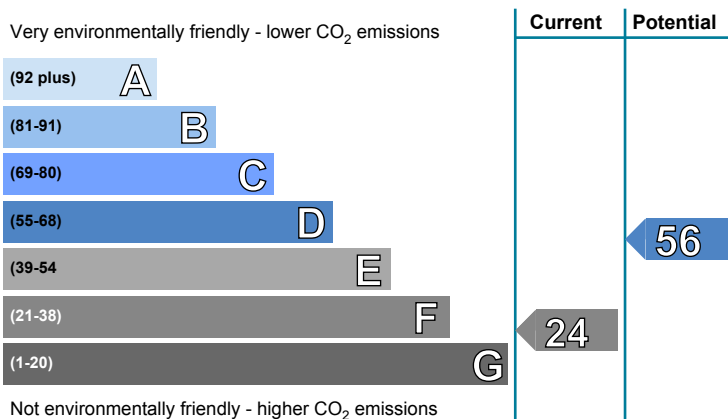
## Environmental Impact (CO<sub>2</sub>) Rating

This graph shows the effect of your home on the environment in terms of carbon dioxide (CO<sub>2</sub>) emissions. The higher the rating, the less impact it has on the environment.

Your current rating is **band F (24)**. The average rating for EPCs in Scotland is **band D (59)**.

The potential rating shows the effect of undertaking all of the improvement measures listed within your recommendations report.
