HOME REPORT

36 TEMPLE WAY
EAST KILBRIDE
GLASGOW
G75 9PP

Energy Performance Certificate (EPC)

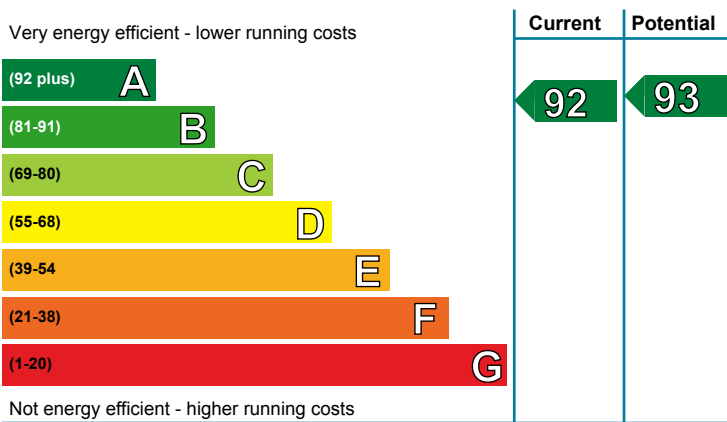
Energy Efficiency Rating

This graph shows the current efficiency of your home, taking into account both energy efficiency and fuel costs. The higher this rating, the lower your fuel bills are likely to be.

Your current rating is **band A (92)**. The average rating for EPCs in Scotland is **band D (61)**.

The potential rating shows the effect of undertaking all of the improvement measures listed within your recommendations report.
