YOUR ONESURVEY  
**HOME REPORT**

35 Sydney Drive  
East Kilbride, Glasgow  
G75 8DQ

# SINGLE SURVEY

A report on the condition of the property, with categories being rated from 1 to 3.

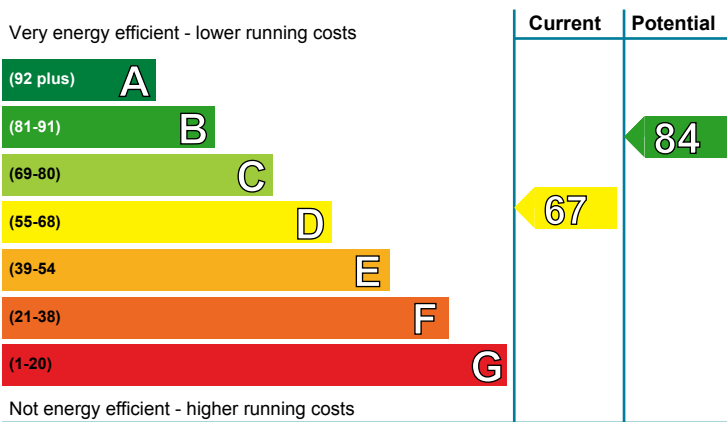
## Energy Efficiency Rating

This graph shows the current efficiency of your home, taking into account both energy efficiency and fuel costs. The higher this rating, the lower your fuel bills are likely to be.

Your current rating is **band D (67)**. The average rating for EPCs in Scotland is **band D (61)**.

The potential rating shows the effect of undertaking all of the improvement measures listed within your recommendations report.

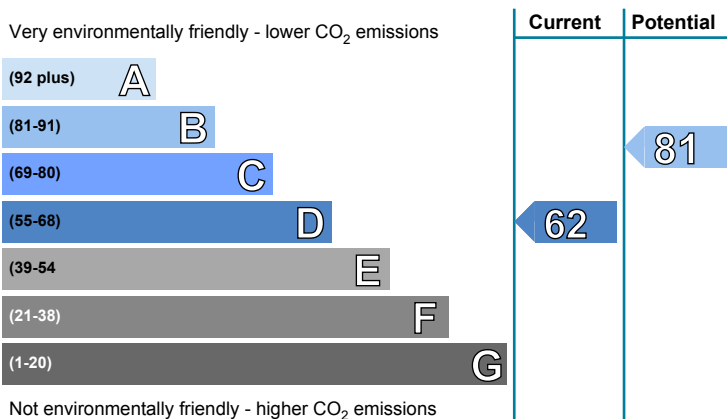
## Environmental Impact (CO<sub>2</sub>) Rating

This graph shows the effect of your home on the environment in terms of carbon dioxide (CO<sub>2</sub>) emissions. The higher the rating, the less impact it has on the environment.
