Home Report

Single Survey

Property address	58 Strathallan Avenue East Kilbride Glasgow G75 8GX
Customer	Estate of the Late John & Margaret Wynne
Customer address	58 Strathallan Avenue East Kilbride Glasgow G75 8GX
Prepared by	Shepherd Chartered Surveyors
Date of inspection	15/01/2025

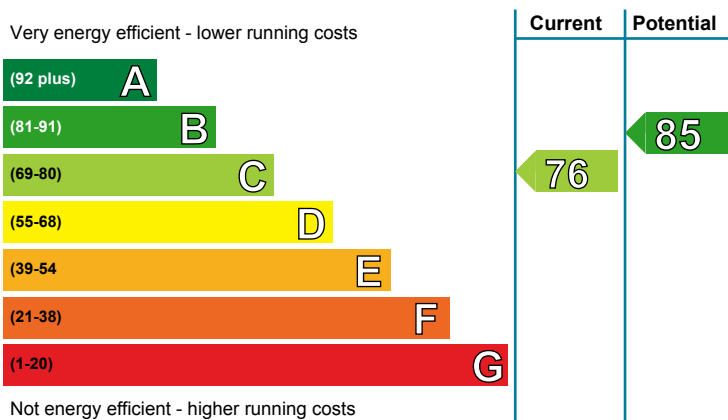
Energy Efficiency Rating

This graph shows the current efficiency of your home, taking into account both energy efficiency and fuel costs. The higher this rating, the lower your fuel bills are likely to be.

Your current rating is **band C (76)**. The average rating for EPCs in Scotland is **band D (61)**.

The potential rating shows the effect of undertaking all of the improvement measures listed within your recommendations report.
