HOME REPORT

2 GRAMPIAN DRIVE
EAST KILBRIDE
GLASGOW
G75 9GL

Energy Performance Certificate (EPC)

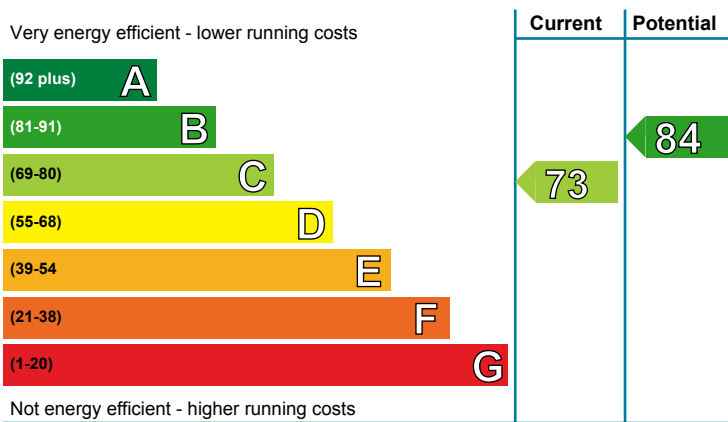
Energy Efficiency Rating

This graph shows the current efficiency of your home, taking into account both energy efficiency and fuel costs. The higher this rating, the lower your fuel bills are likely to be.

Your current rating is **band C (73)**. The average rating for EPCs in Scotland is **band D (61)**.

The potential rating shows the effect of undertaking all of the improvement measures listed within your recommendations report.
